INTEROFFICE CORRESPONDENCE

DATE: August 5, 1991

SUBJECT: OPERATIONS AND SURVEILLANCE REPORT CONCERNING THE SOUTH INTERCEPTOR
DITCH -- DSM-016-91

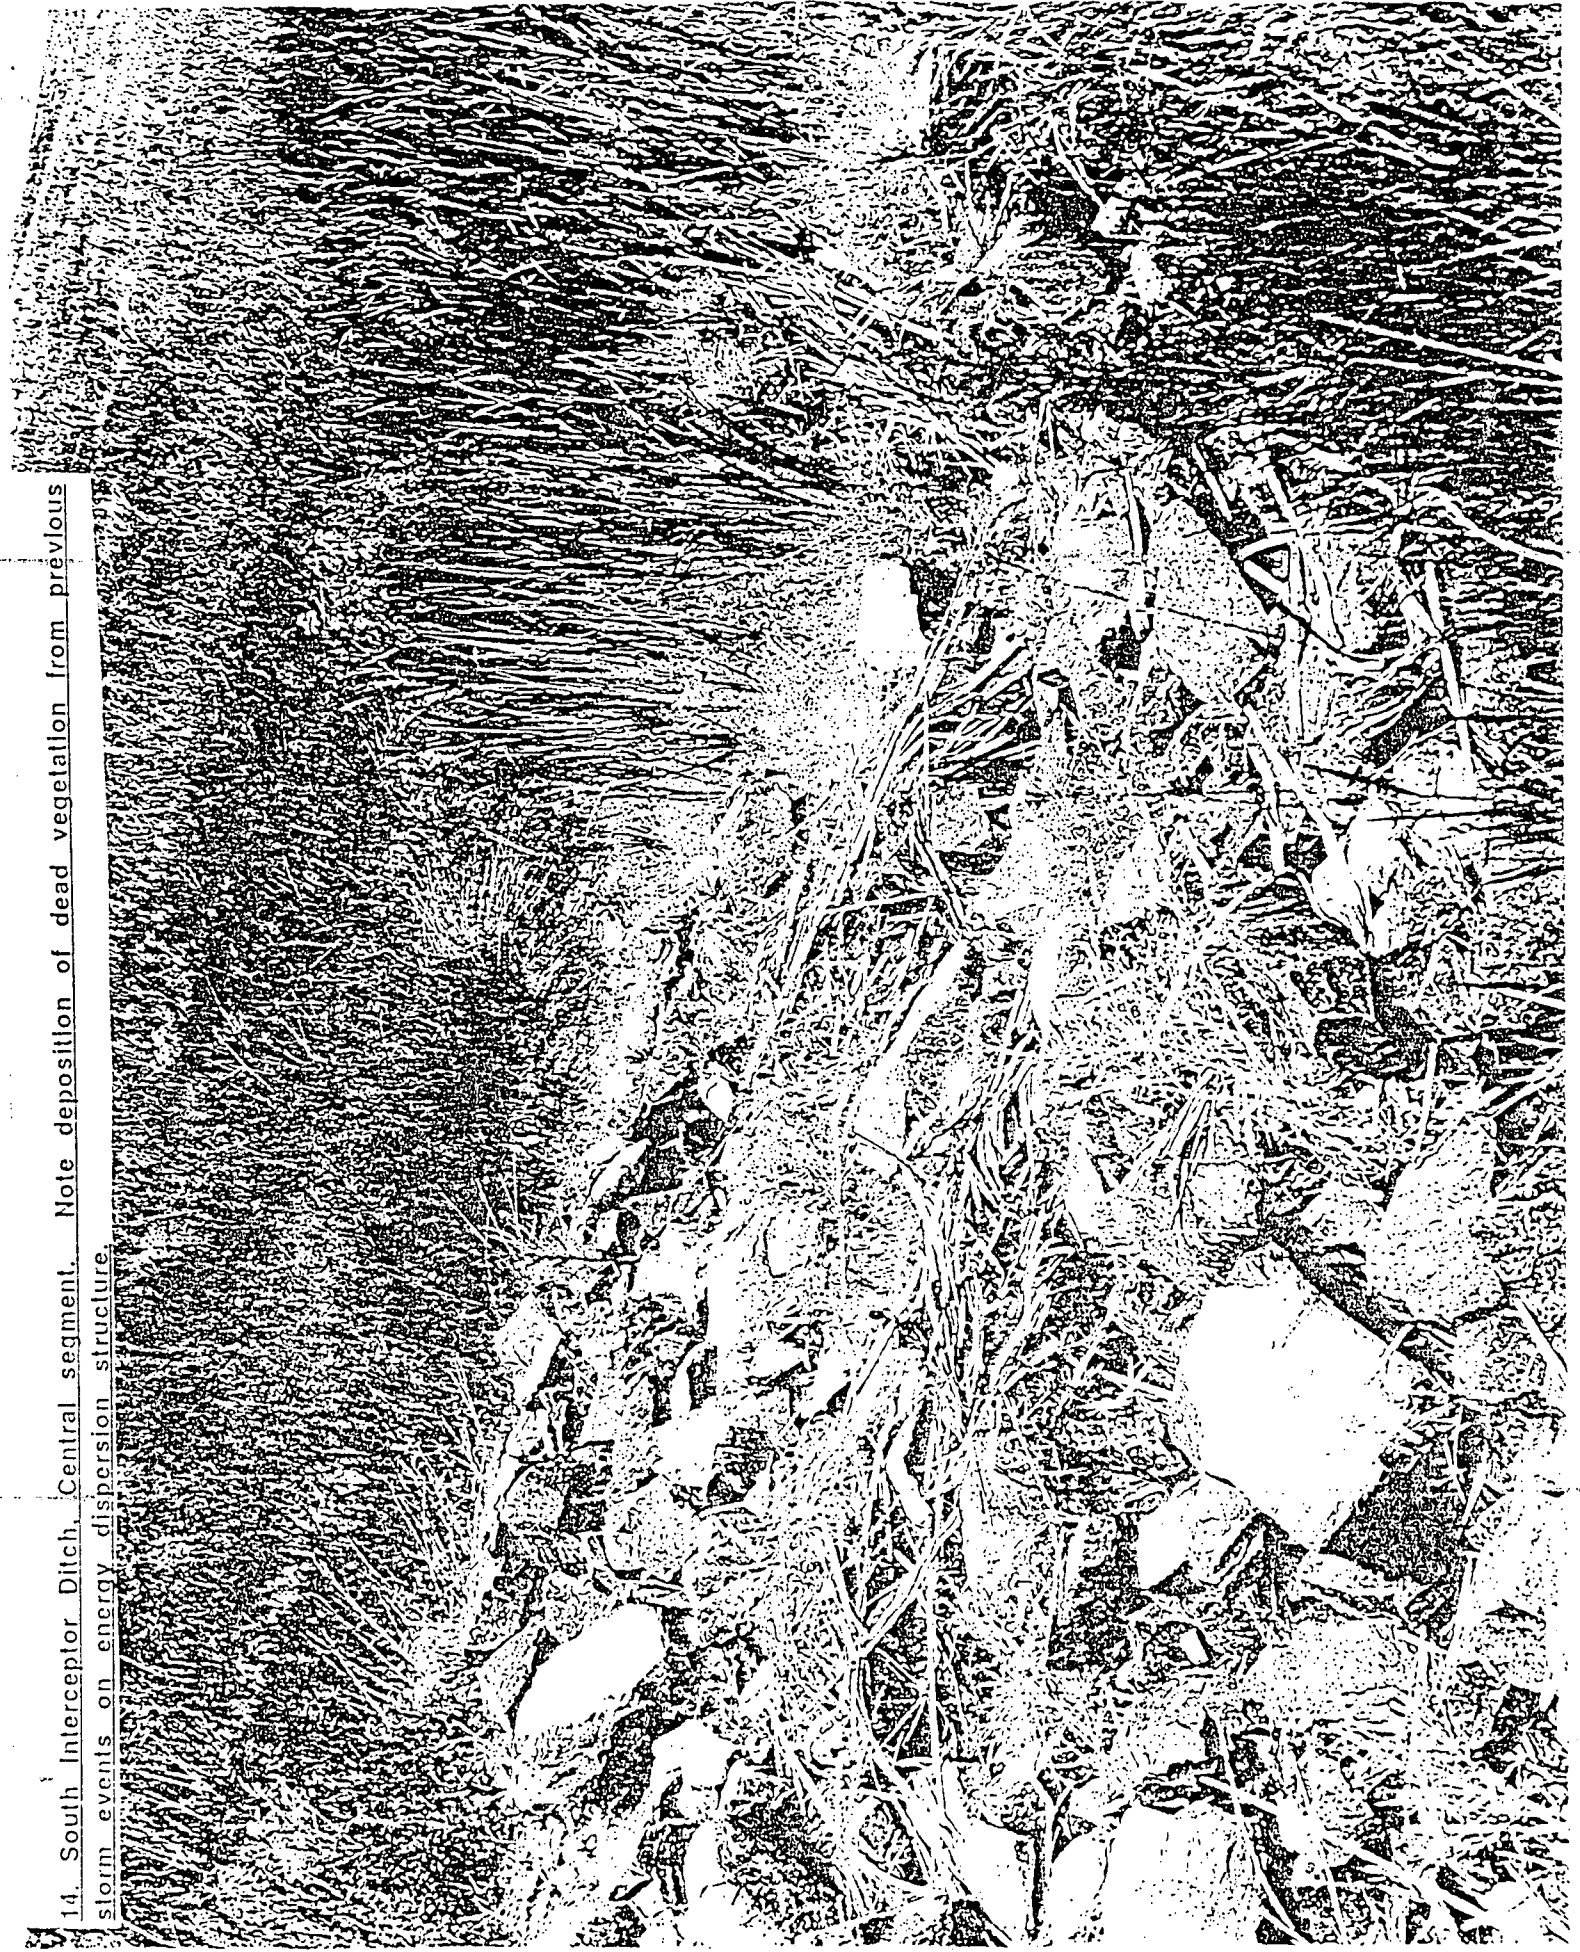
14. South Interceptor Ditch, Central segment. Note deposition of dead vegetation from previous storm events on energy dispersion structure.

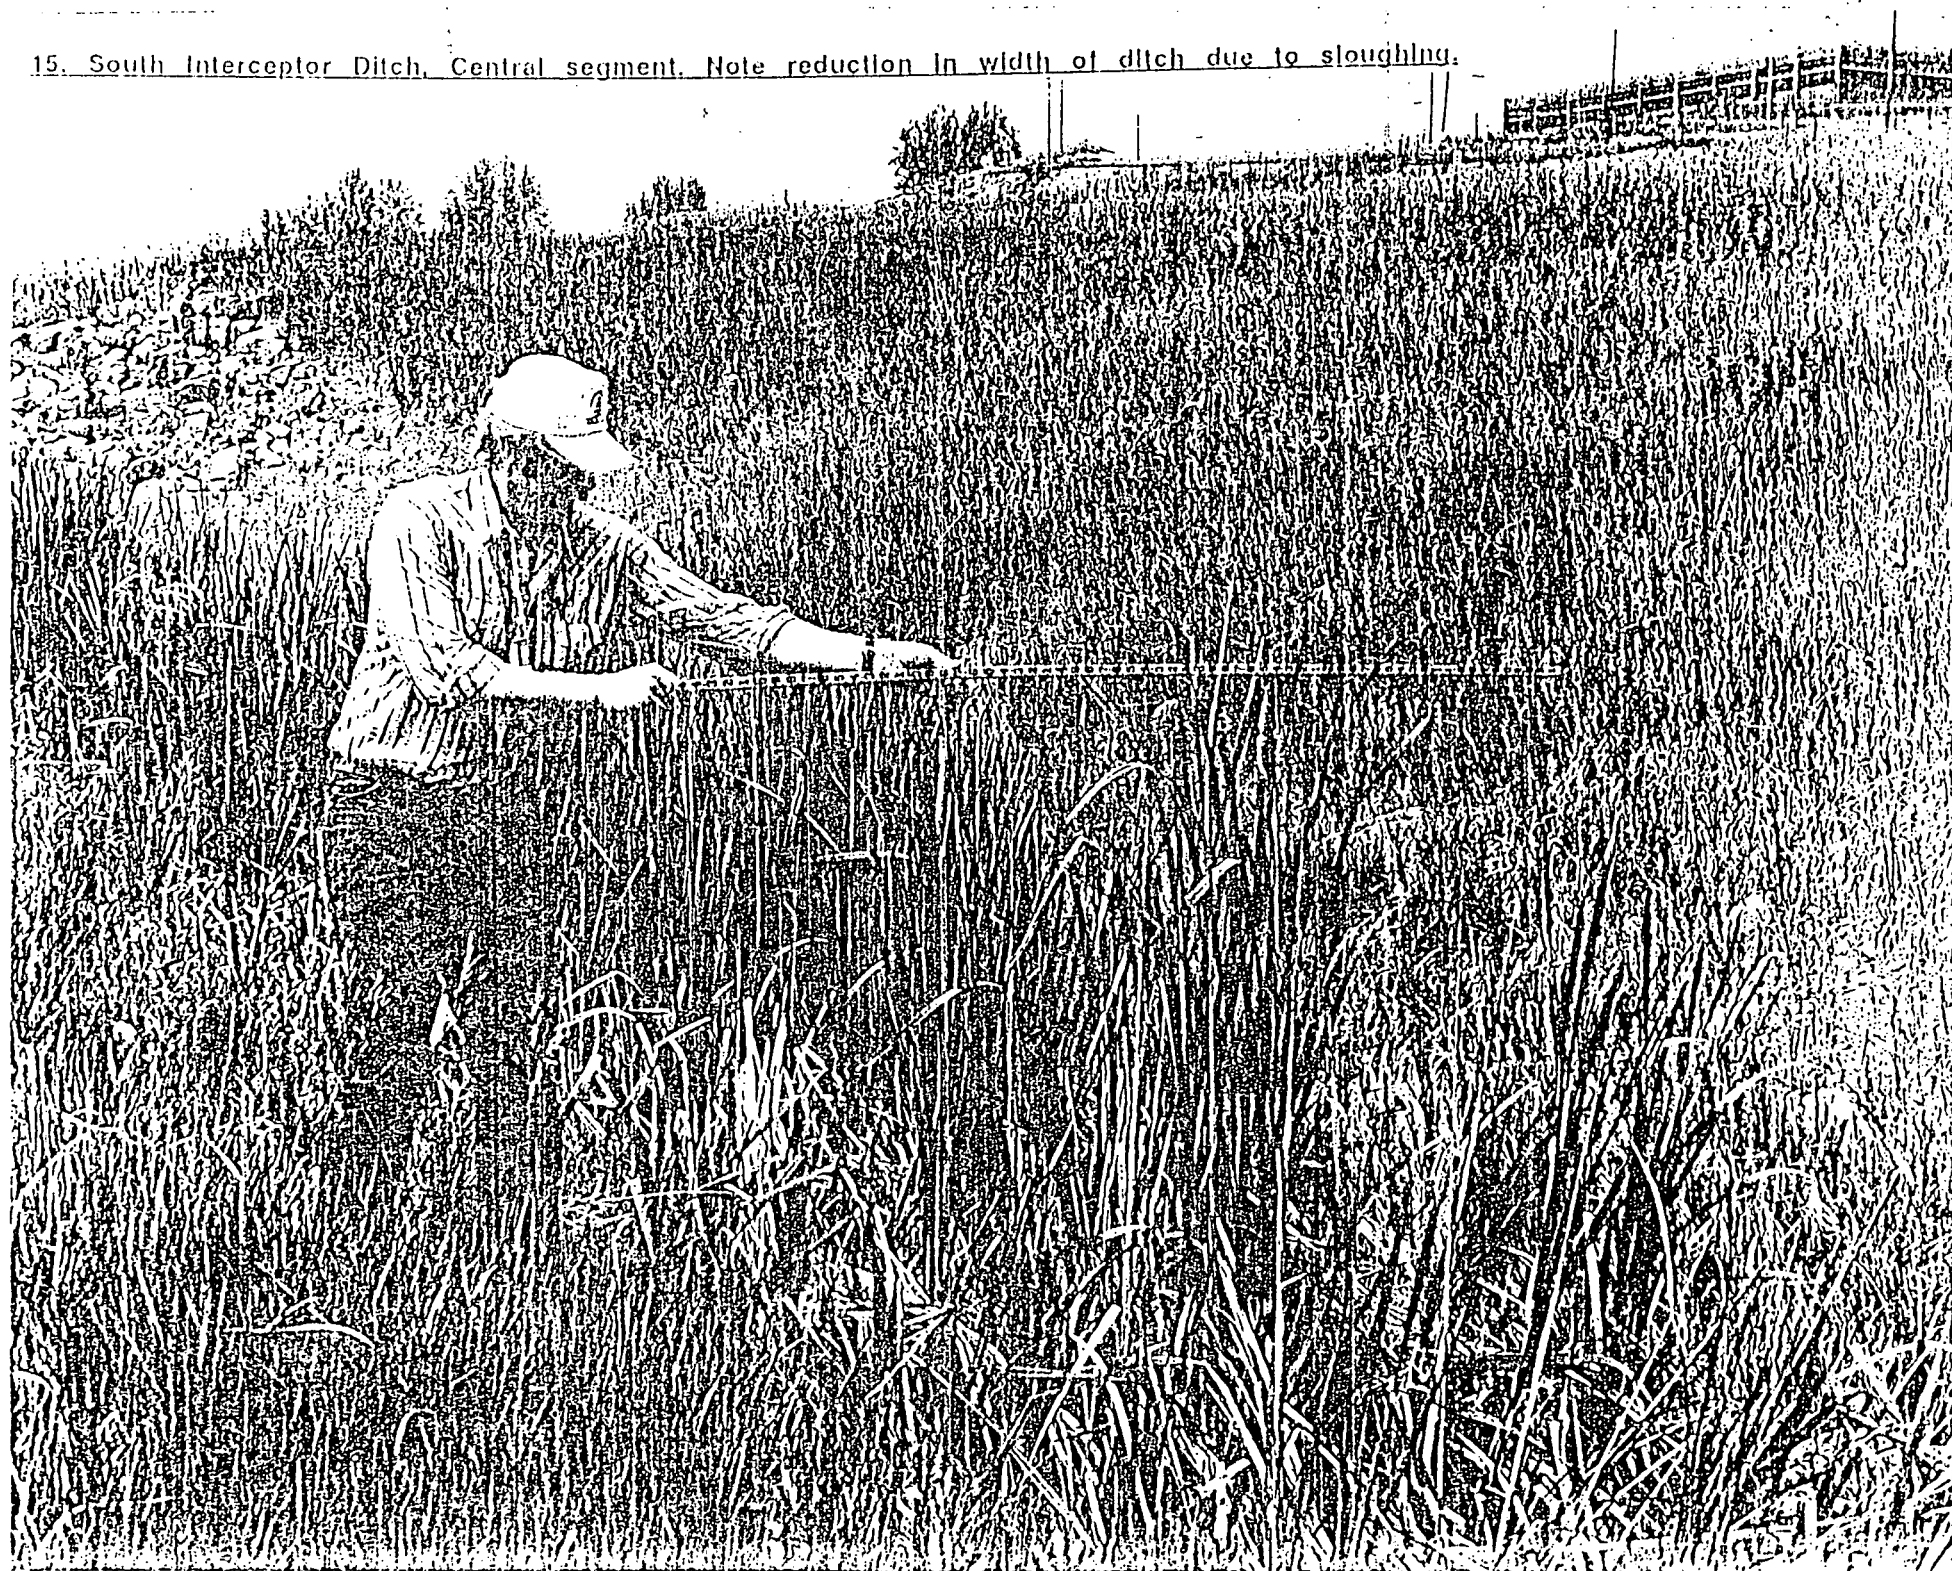
15. South Interceptor Ditch, Central segment. Note reduction in width of ditch due to sloughing.

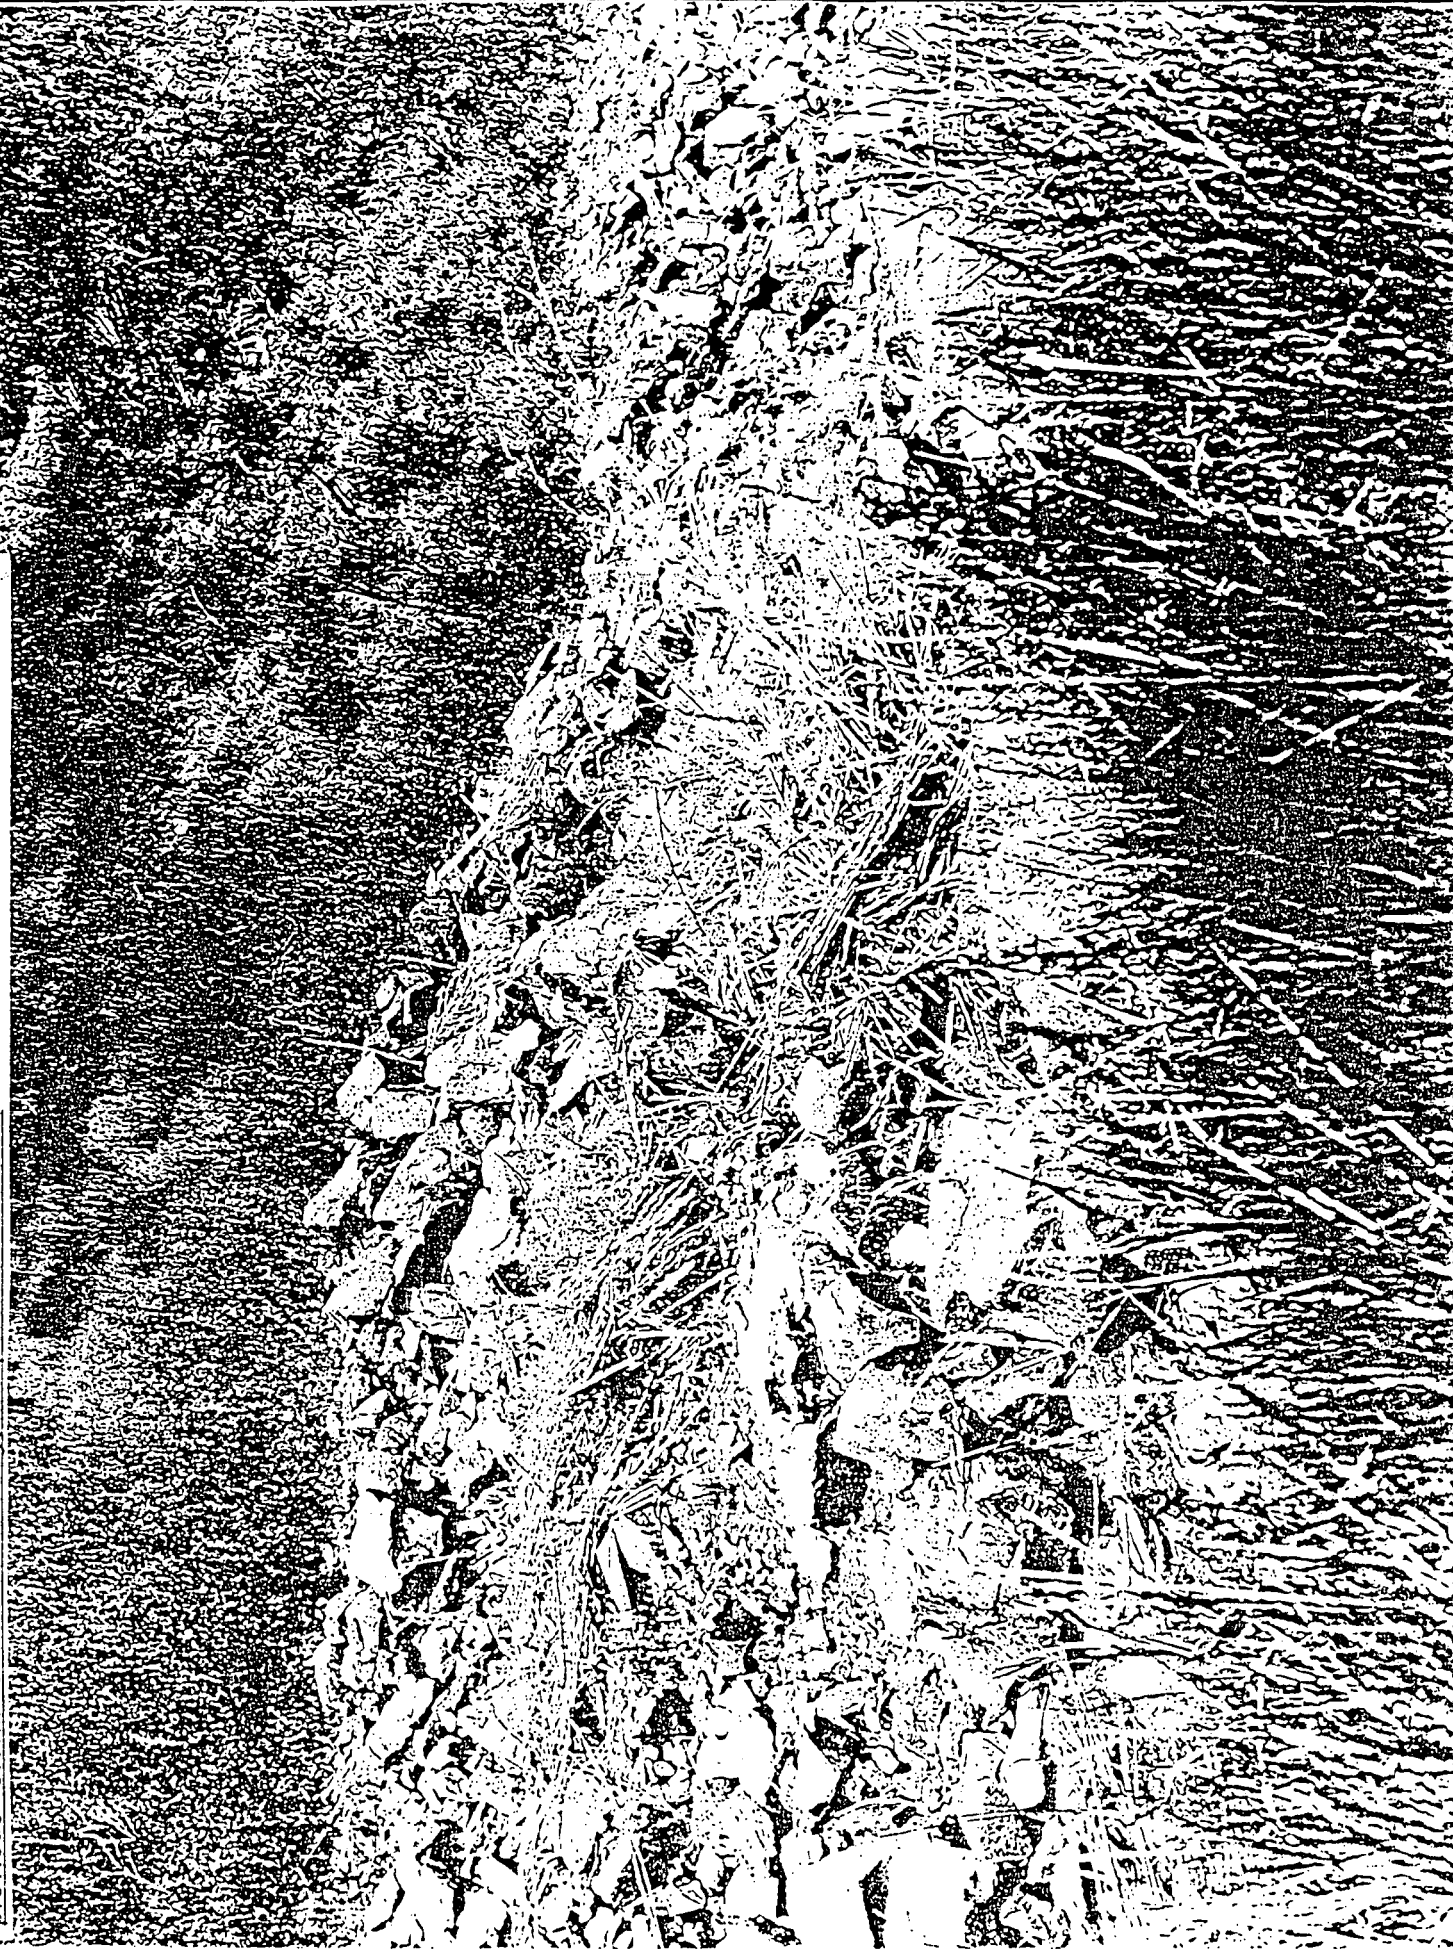
16. South Interceptor Ditch, Central segment. Note deposiiton of vegetative material from previous storm events on energy disperslon structure.

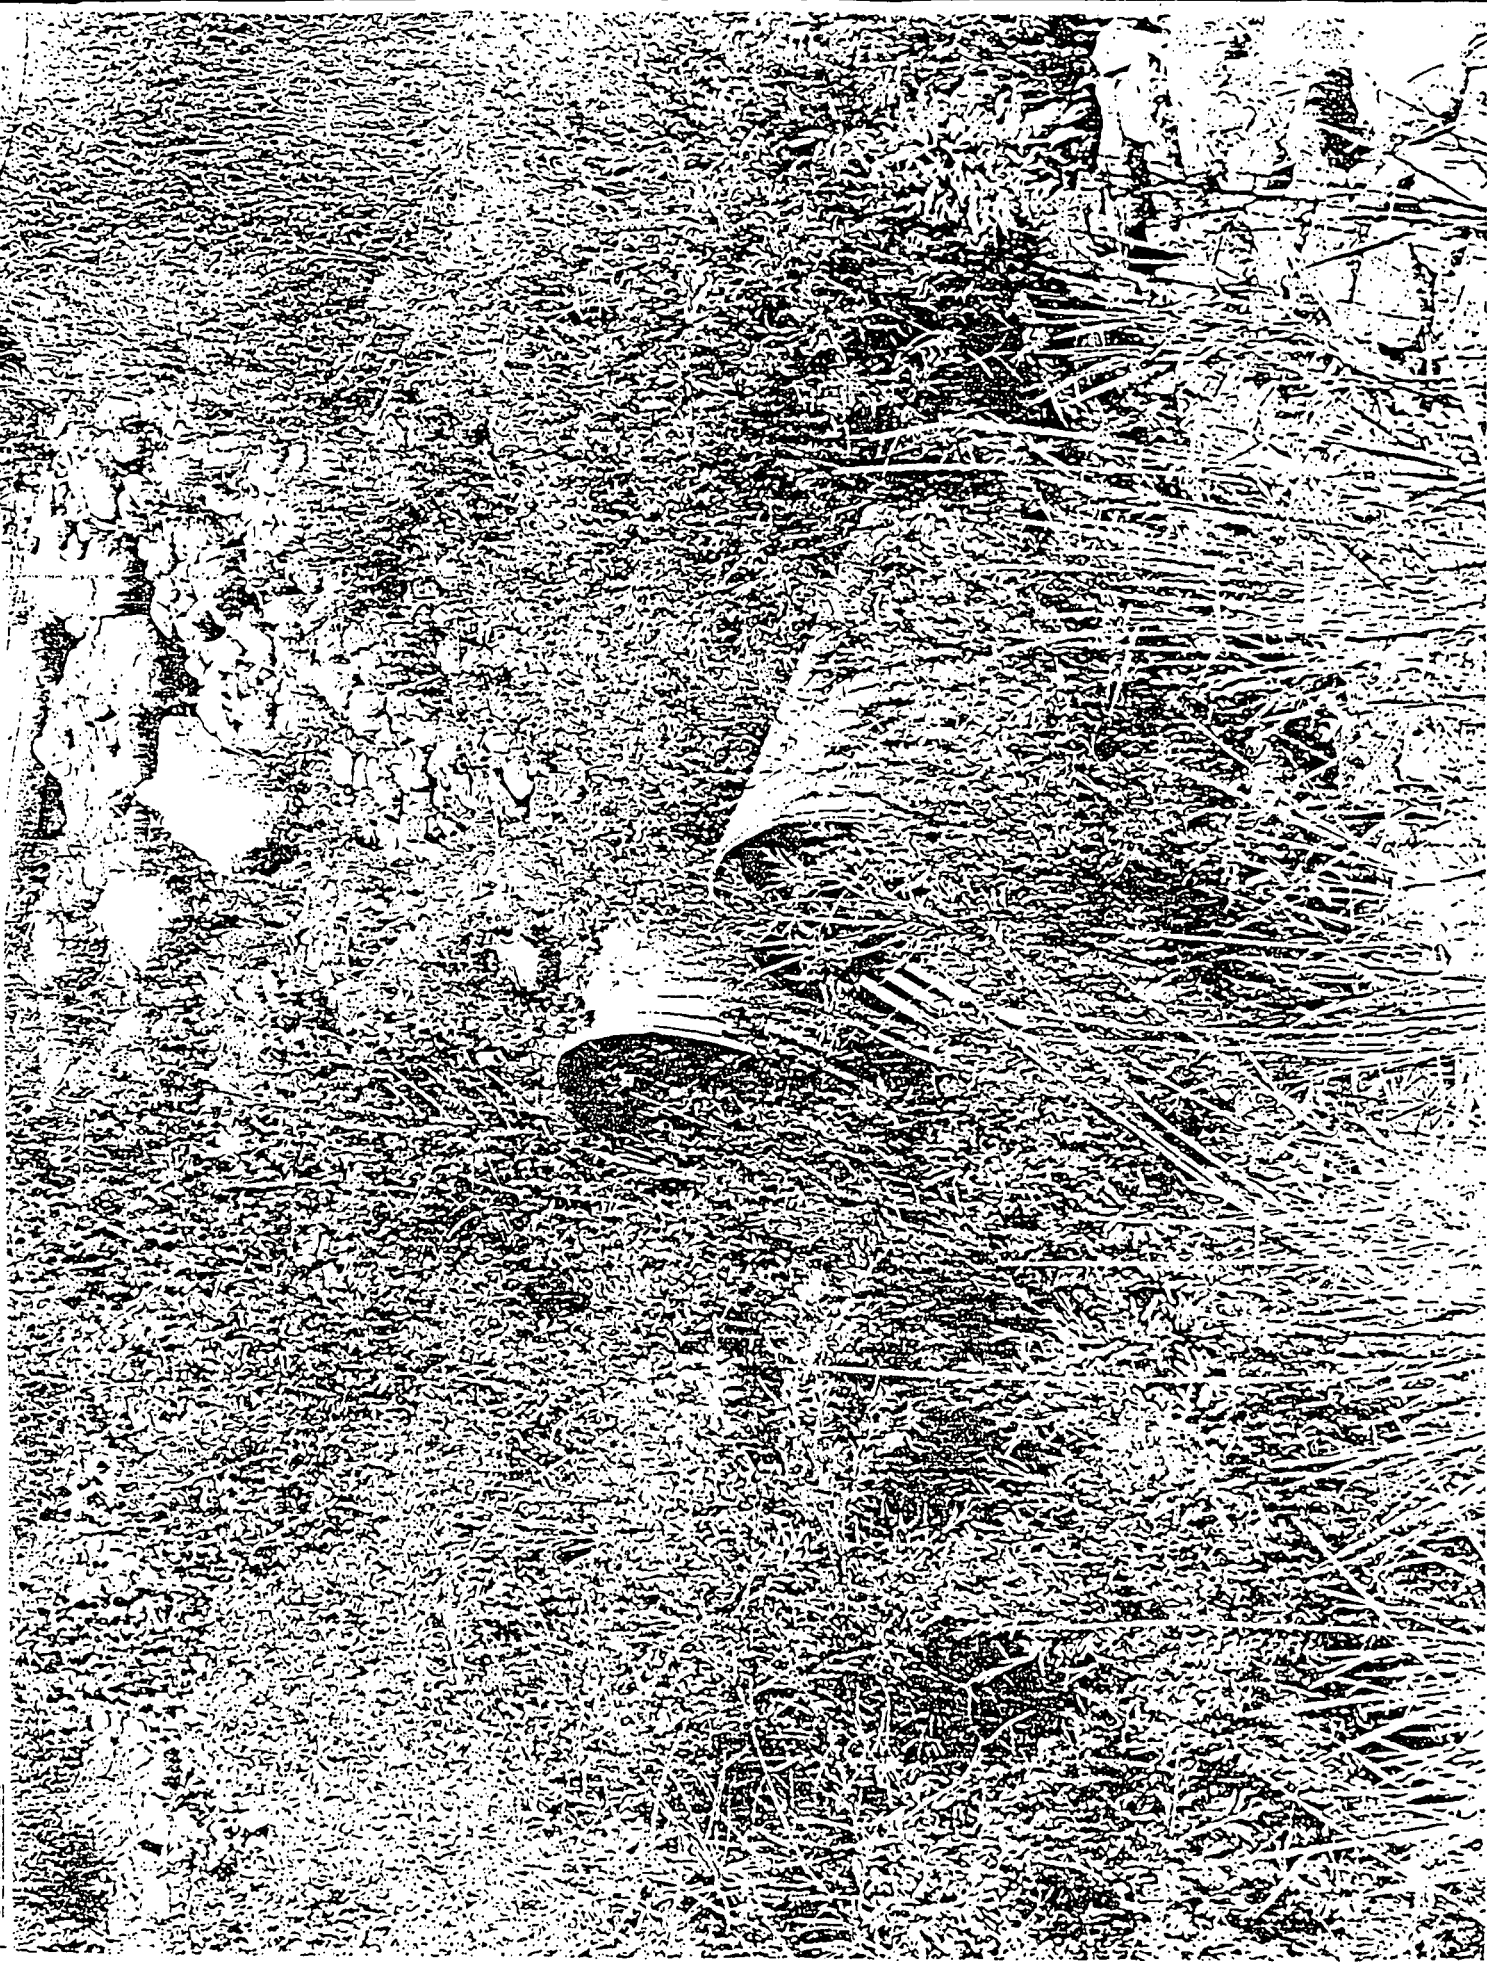
20. South Interceptor Ditch, East segment. Note vegetative growth on upstream portion of culverts.

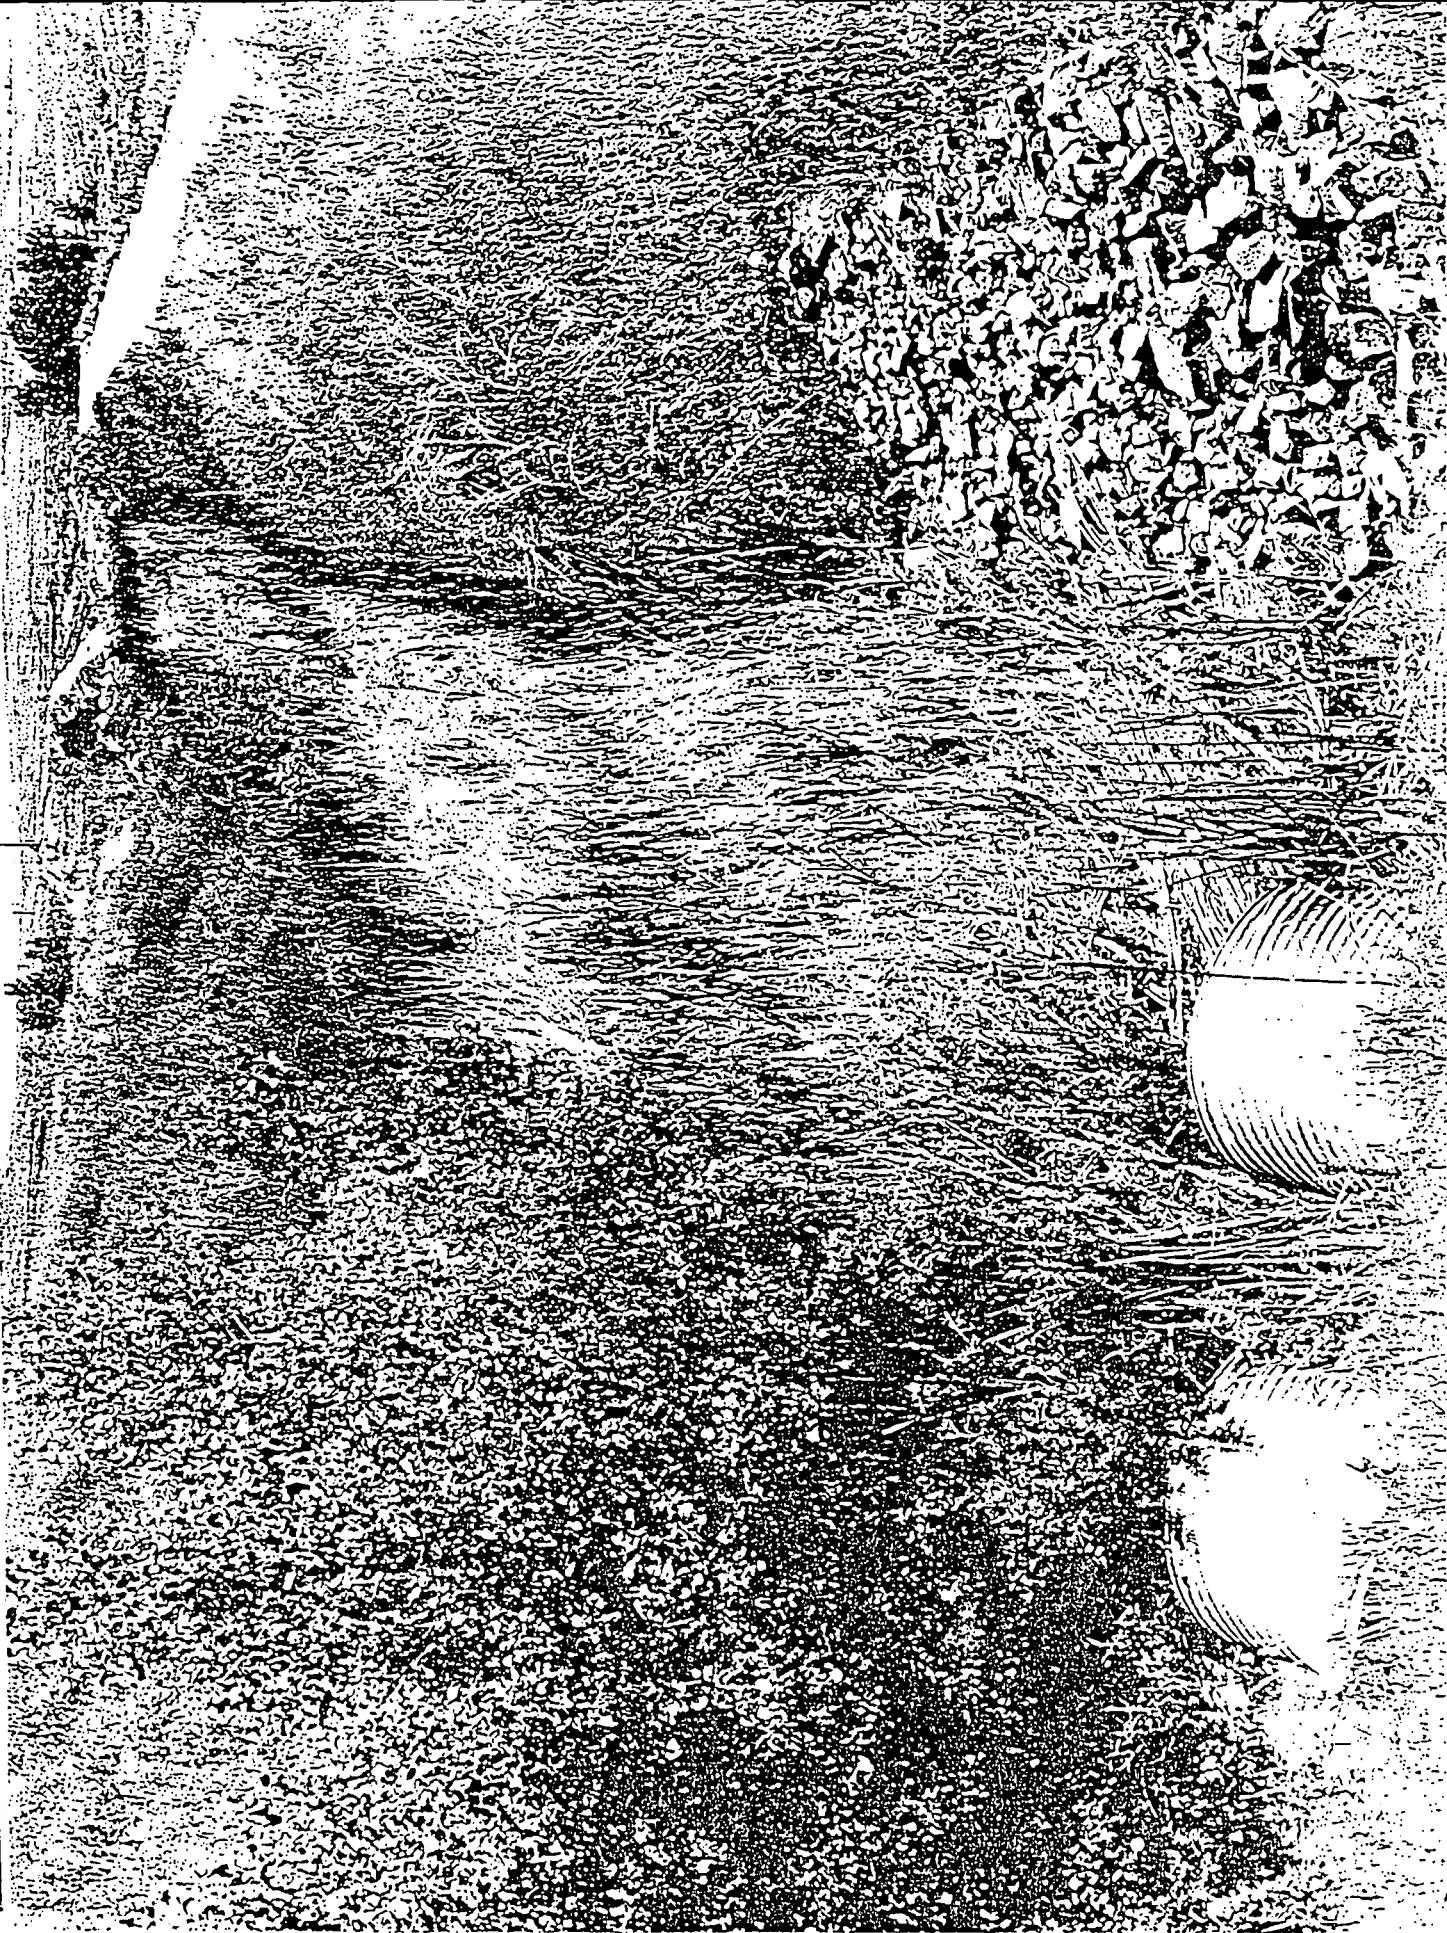
21. South Interceptor Ditch, East segment, East aspect. Note vegetative growth on downstream portion of culverts.

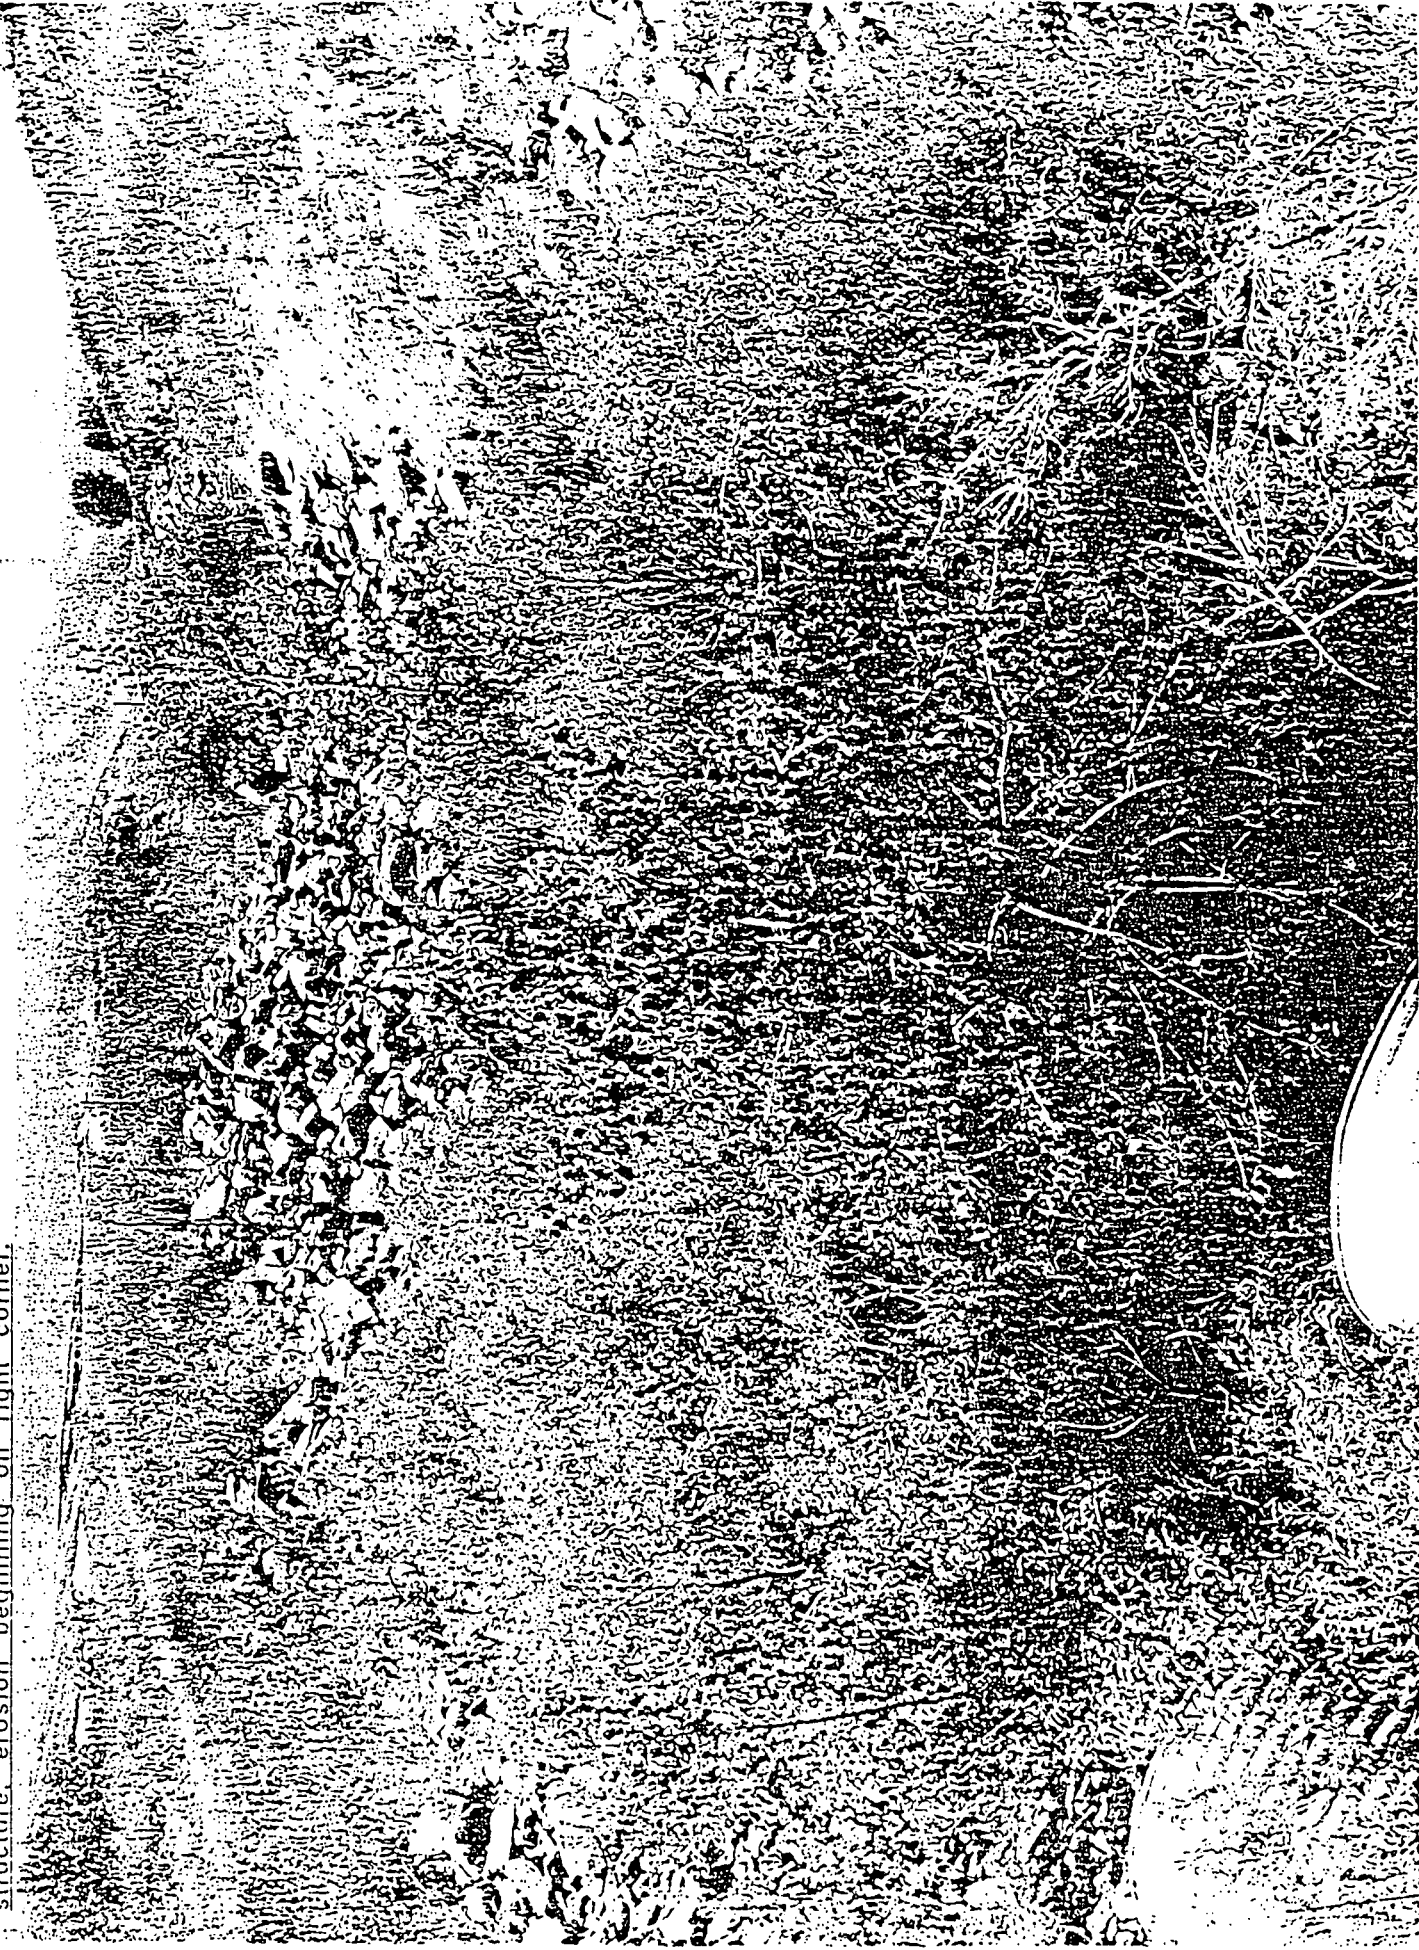
22. South Interceptor Ditch, East segment, West aspect. Note vegetative (trees) growth on upstream portion of culverts. Note condition of (movement) of rip-rap on energy dispersion structure, erosion beginning on right corner.

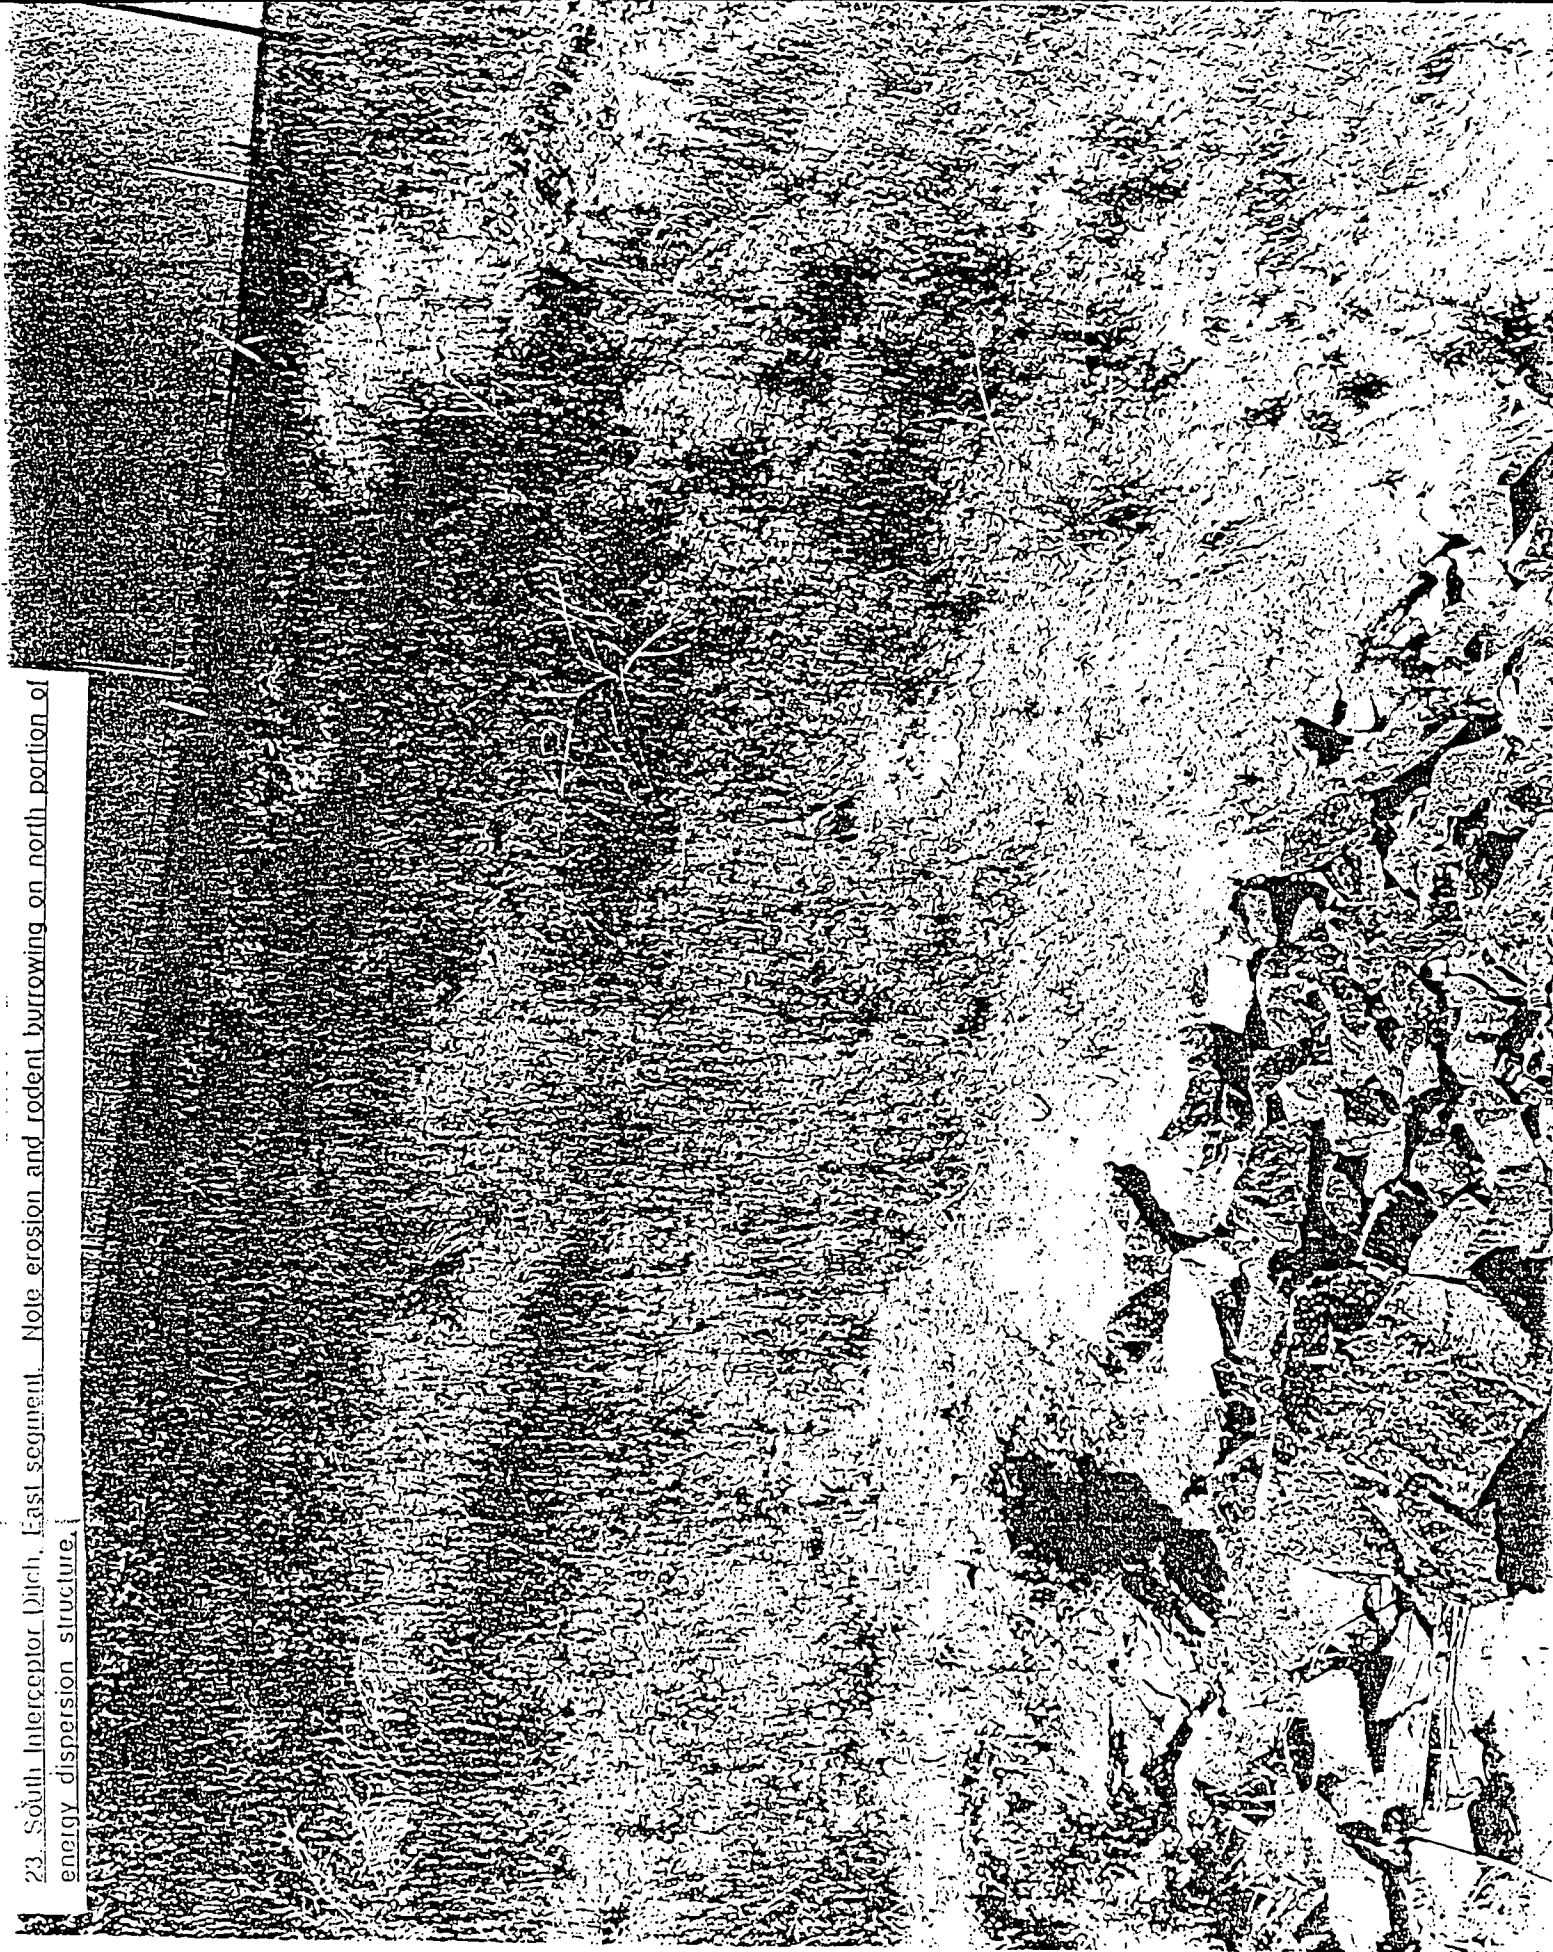
23. South Interceptor Ditch, East segment. Note erosion and rodent burrowing on north portion of energy dispersion structure.
